**COMPREHENSIVE MOTOR VEHICLE SERVICES AND
CONSULTING
MOTOR VEHICLE FORENSIC ANALYSIS
REPORT**

CMVSC-18-IA-245

-- In the Matter of the Death of Edson Thevenin --

INVOLVED DYNAMIC SUBJECT VEHICLE: 2000 Honda Civic EX Two Door Coupe

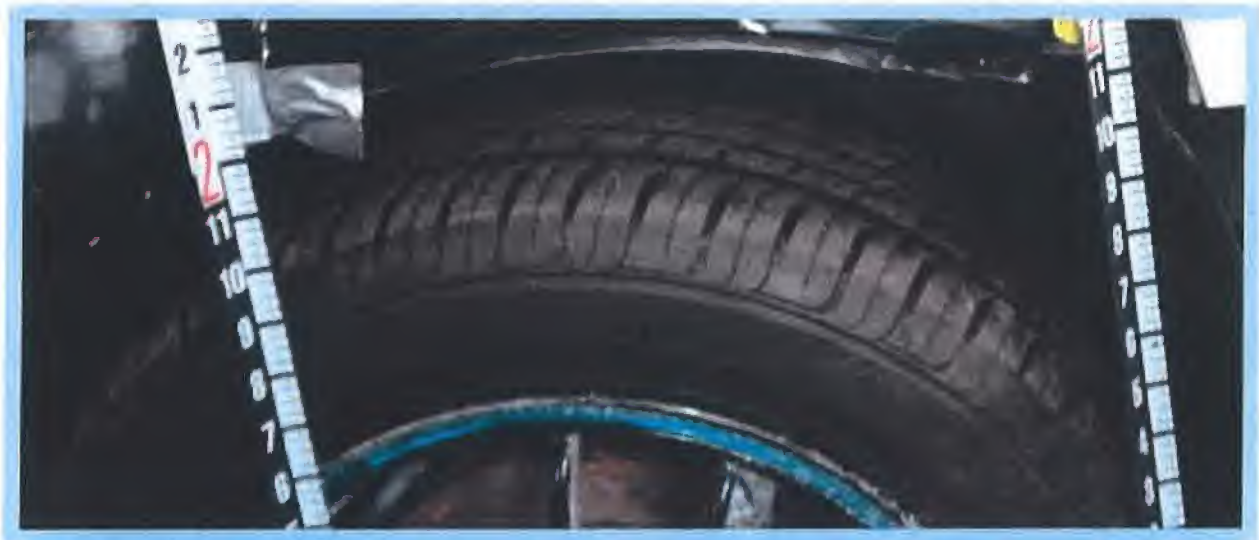
Image No. 9 This photograph of the right front tire of the 2000 Honda Civic operated by Eileen Djevorn depicts an example of the condition of the tires of the vehicle. The vehicle autopsy revealed no tire conditions which would have adversely affected the operational characteristics of the 2000 Honda Civic.

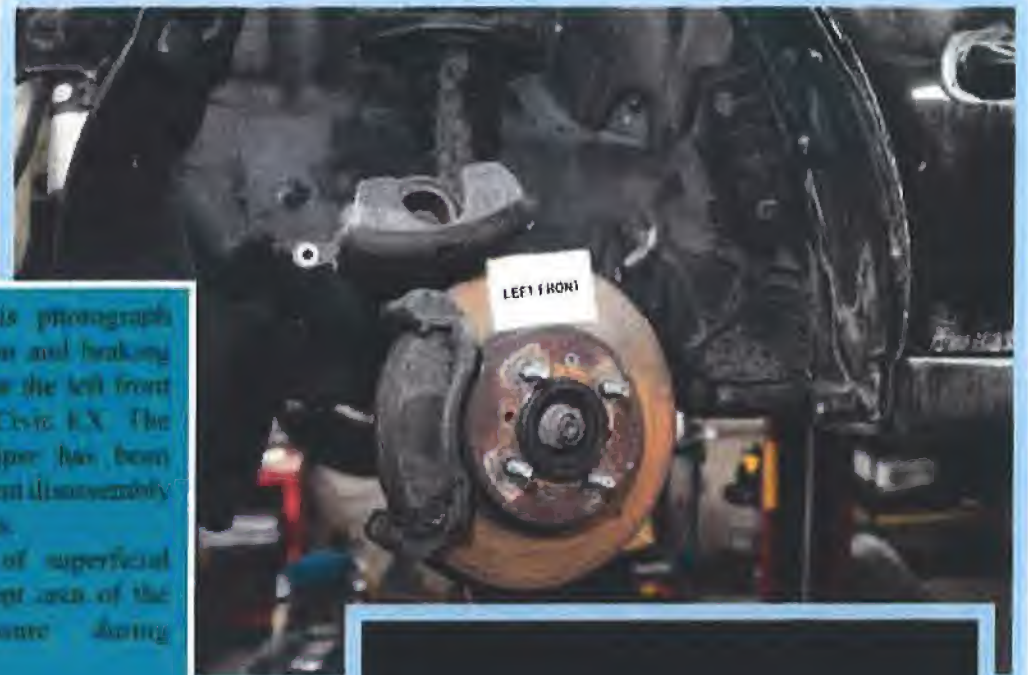
Image No. 10 This photograph depicts the suspension and braking components located at the left front of the 2000 Honda Civic EX. The left front brake caliper has been removed for component disassembly and testing procedures. Note the presence of superficial oxidation on the swept area of the rotor from exposure during impoundment.

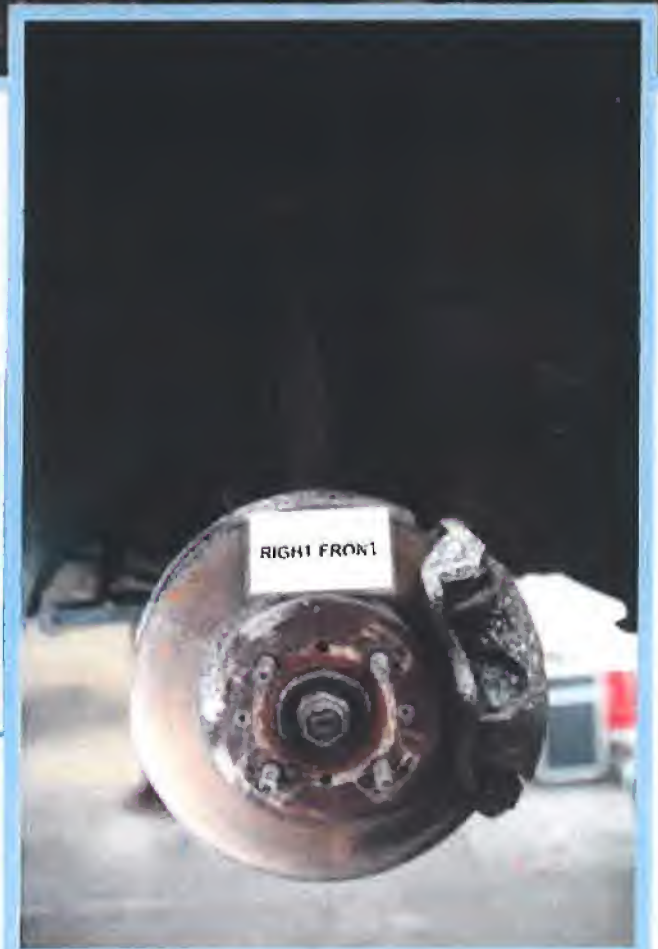
Image No. 11 This photograph depicts the suspension and braking components located at the right front of the 2000 Honda Civic. Note the minimal brake disc accumulation, consistent with no high speed emergency braking during vehicle crash sequence operation.

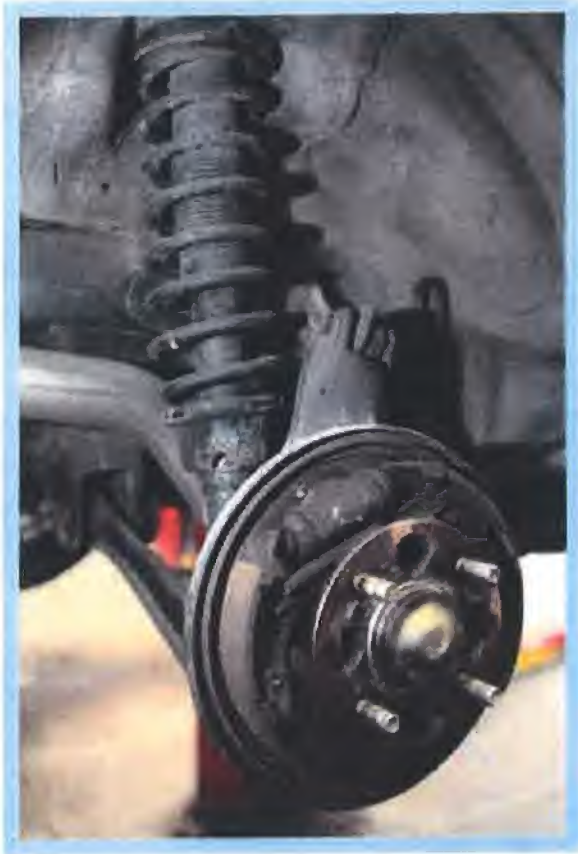
Image No. 12 This photograph depicts the suspension and braking components located at the right rear of the 2000 Honda Civic. Near the wheel cylinder, with an wheel cylinder brake fluid seepage.

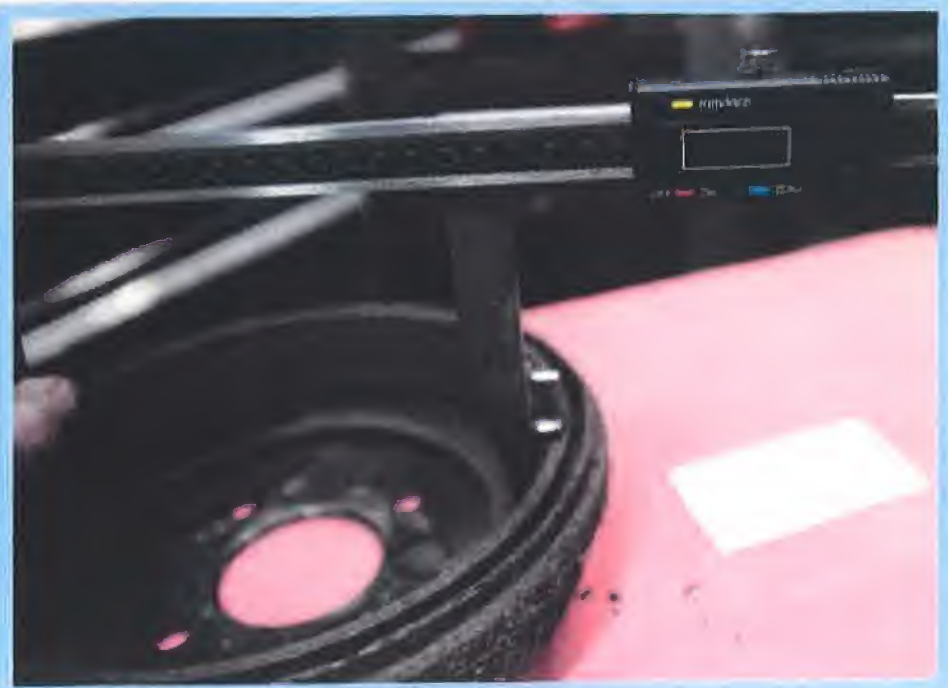
Image No. 13 This photograph depicts the brake drum located at the right rear of the 2000 Honda Civic. Wear measurement readings of the brake shoe contact areas of the brake drum exceeded minimum specifications.

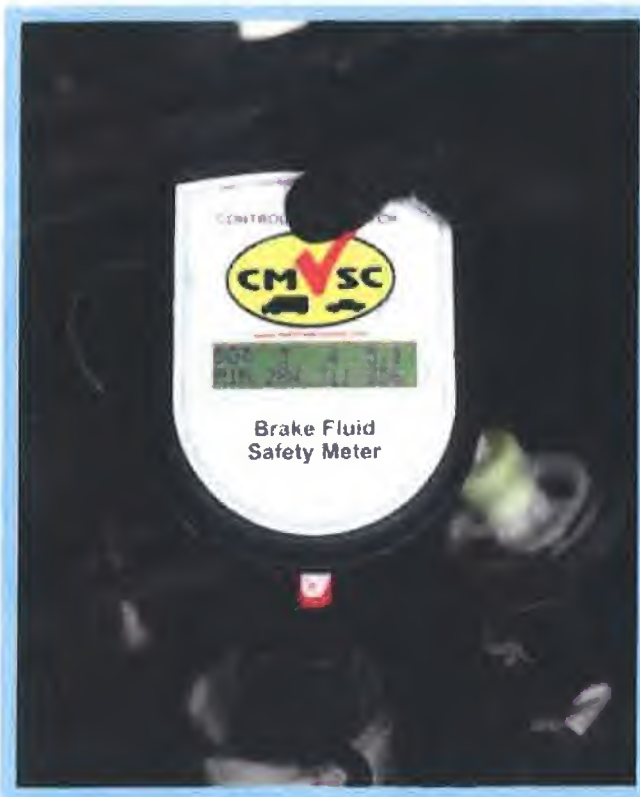
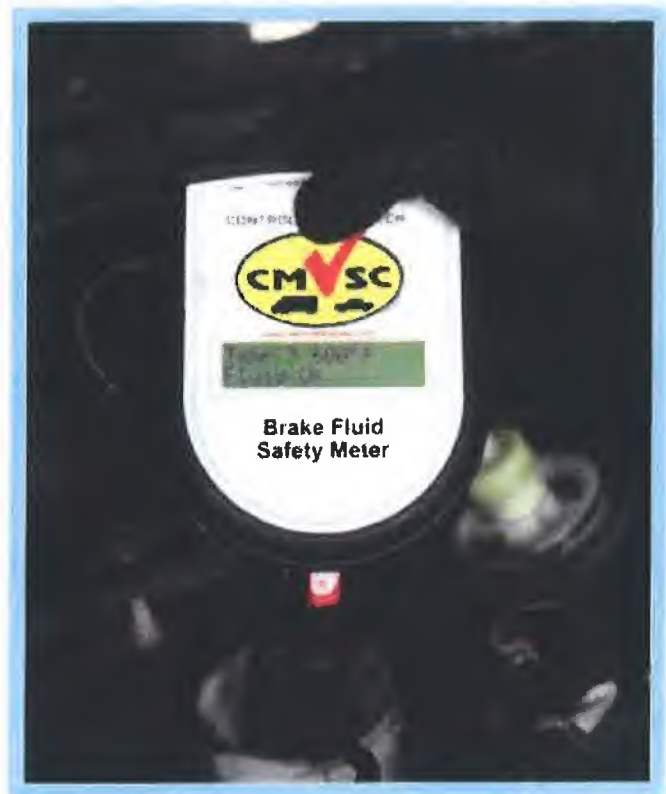
Images No. 14a & 14b: These photographs depict the testing analysis of the brake fluid of the involved 2000 Honda Civic EX to 600 degrees Fahrenheit. The results were that the hygroscopic properties of the brake fluid met/exceeded standards.

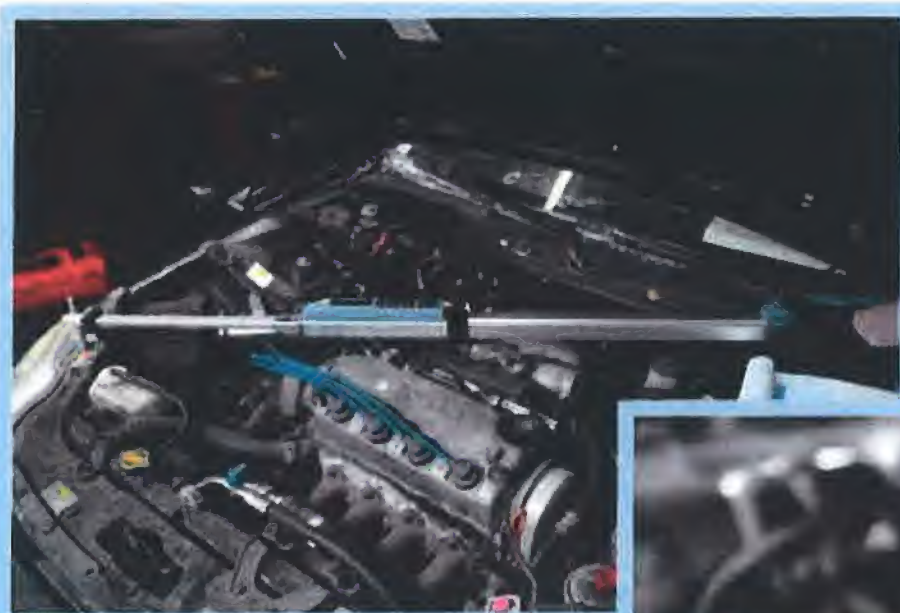
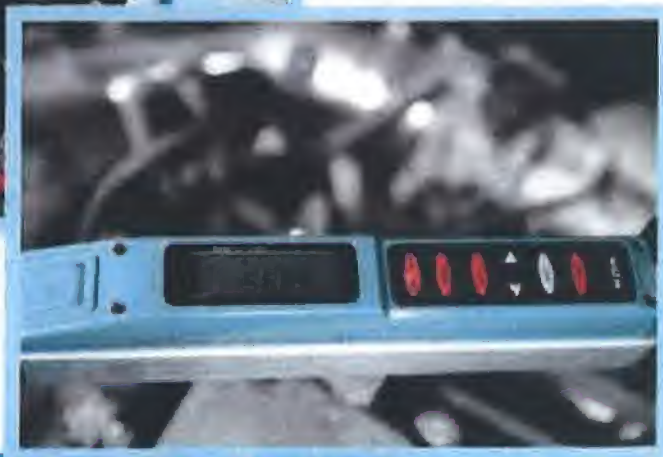
- ◆ Power rack and pinion steering components intact and functional.
- ◆ Steering wheel rotation resulted in positive front wheel/tire steering action; however, normal lock-to-lock transition was limited due to extreme front wheel toe out condition from severity of frontal impact with concrete barrier.
- ◆ No measureable free play -- steering wheel rotation/front tire/wheel steering action.
- ◆ Steering wheel exhibited significant deformation due to unrestrained driver impact forces.
- ◆ No measurable play at tie rod ends.
- ◆ No measurable play at lower front/rear bushings/ball joints, strut joints, or wheel bearings.
- ◆ Front subframe displaced rearward from left front vehicle violent impact with concrete barrier, resulting in diamond dimension deformation of approximately 1.22 inches.

Images No. 15a & 15b These photographs depict the digital gauge analysis of the extent of structural damage sustained as the result of the violent impact of the left front end of the 2000 Honda Civic with the concrete barrier. The energy of the impact resulted in diamond deformation of the forward V-Axis.

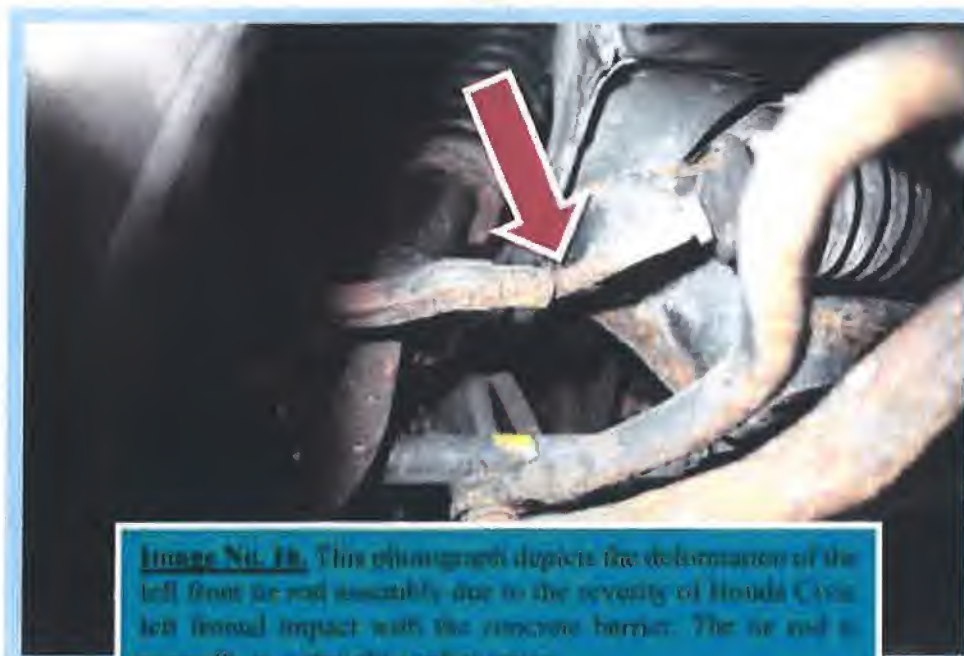
- ◆ Power steering pump pulley immobile due to impact damage resulting in absence of power steering assist⁵.
- ◆ Left front tie rod assembly steering components exhibited extreme deformation from vehicle violent impact with concrete barrier, contributing to front wheel toe out condition of approximately 17.4 degrees⁶.
- ◆ No evidence whatsoever of pre-crash component failure.

Image No. 16. This photograph depicts the deformation of the left front tie rod assembly due to the severity of Honda Civic left frontal impact with the concrete barrier. The tie rod is normally in a straight configuration.

This deformation as well as substantial deformation resulted in a front wheel toe out condition of approximately 1° 4 degrees.

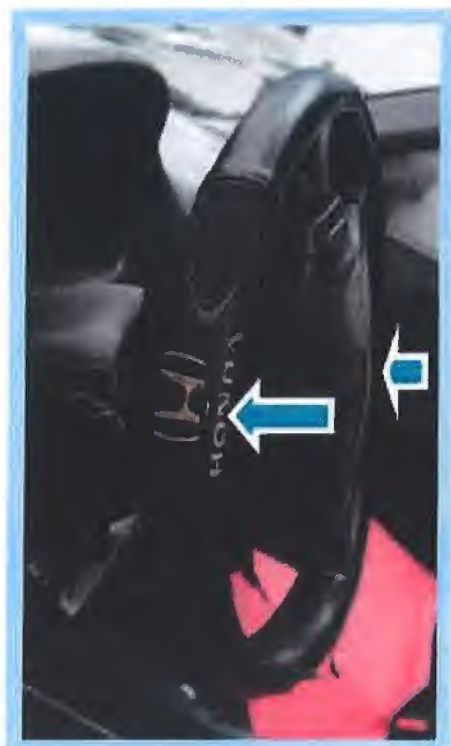
Image No. 17. This photograph depicts the obvious deformation of the steering wheel of the 2000 Honda Civic consistent with the impact energy of unrestrained belted Adam Fleischer in impact with the concrete barrier.

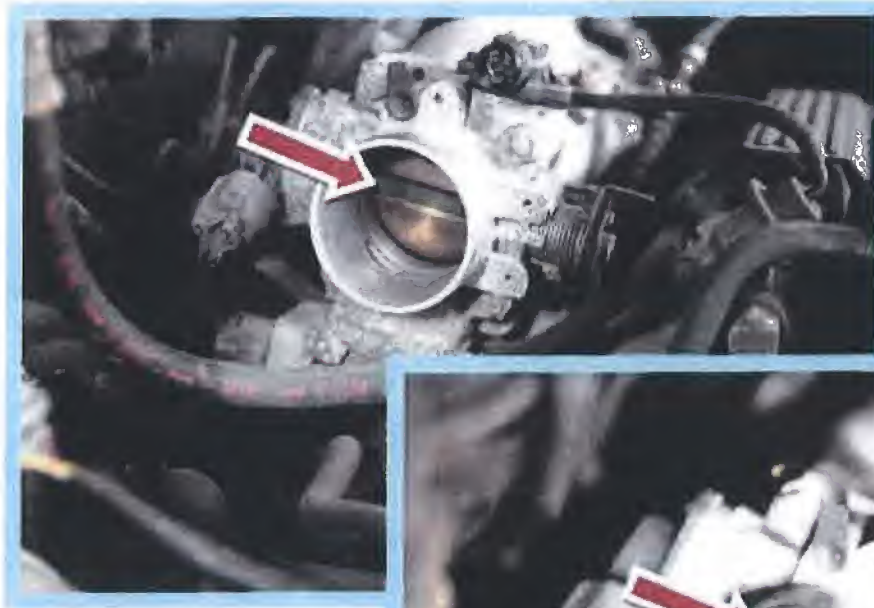
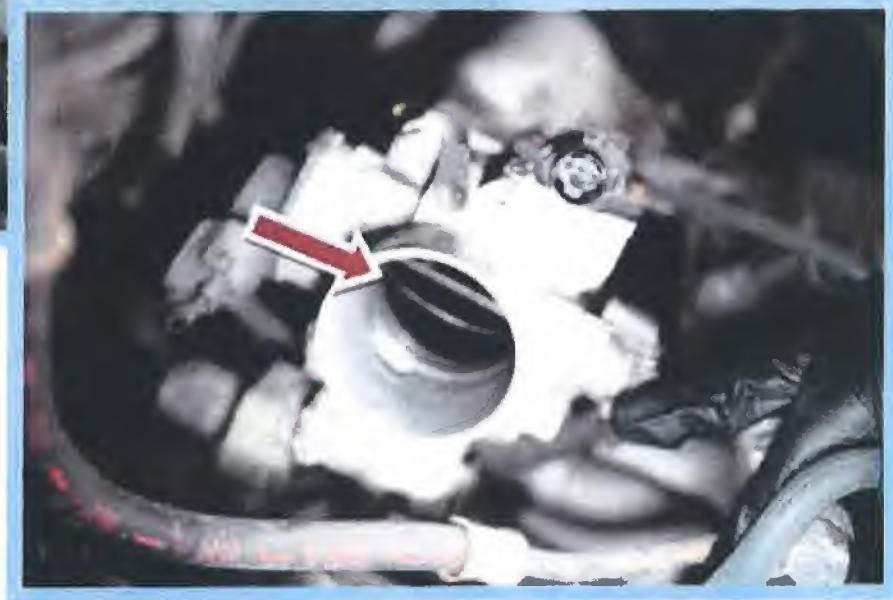
Images No. 11a & 11b. These photographs depict the Throttle Body of the involved 2000 Honda Civic operated by Edison Trevino. The Red Arrow denotes the Throttle Plate, which is mechanically restrained to the closed (engine idle) position.

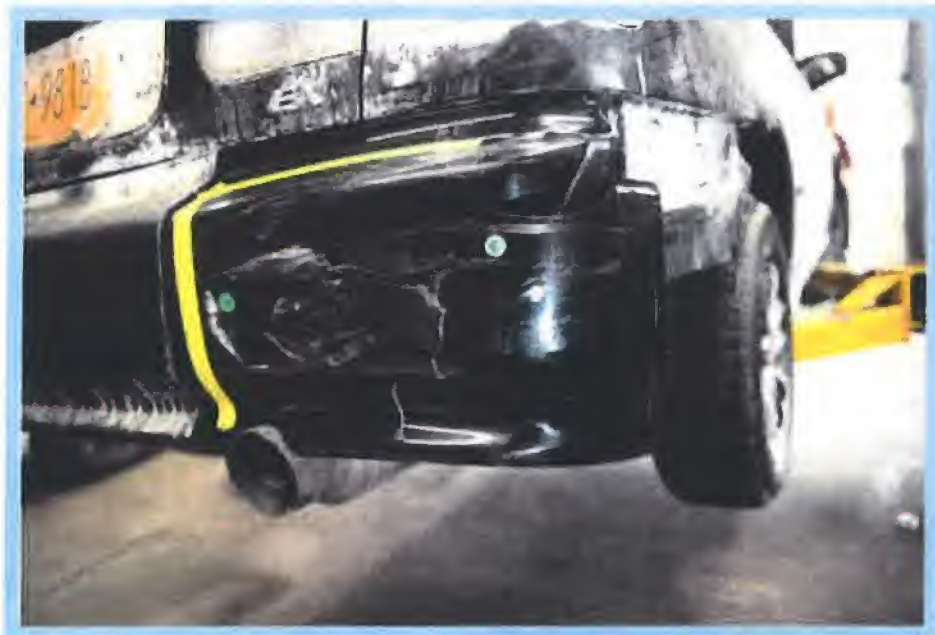
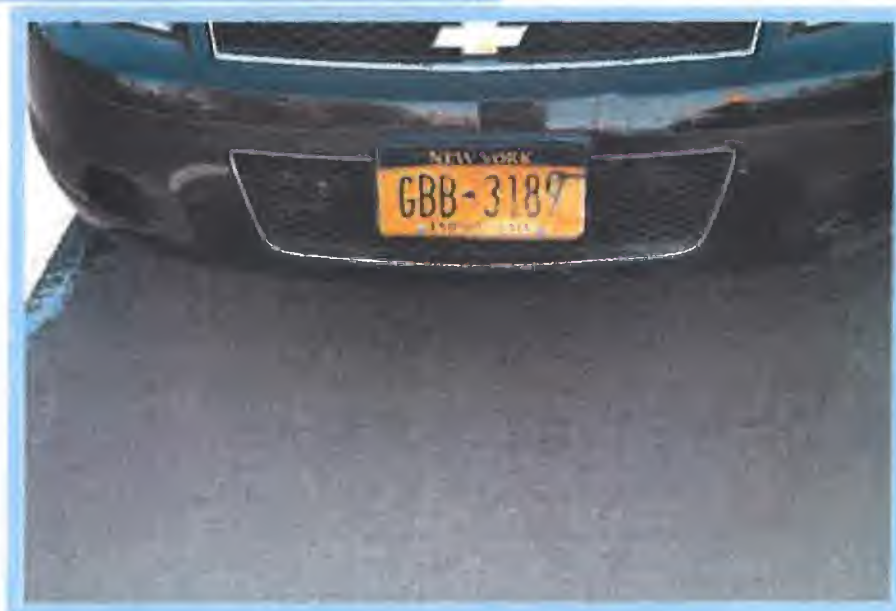
1) **Location of Damage:** Right Rear Bumper Cover.

Description of Damage: Paint scuffing/scratching; paint delamination; fracturing of plastic rear bumper cover material.

Analysis of Damage: Consistent with impact with frontal front bumper cover area of Troy Police Department 2012 Chevrolet Impala as the result of rearward backing trajectory of 2000 Honda Civic.

Images No. 25a & 25b. These photographs depict the impact damage of the right rear bumper cover of the 2000 Honda Civic (top photo), consistent with rear-end (backing) impact with the front bumper area of the Troy Police Department 2012 Chevrolet Impala (bottom photo).

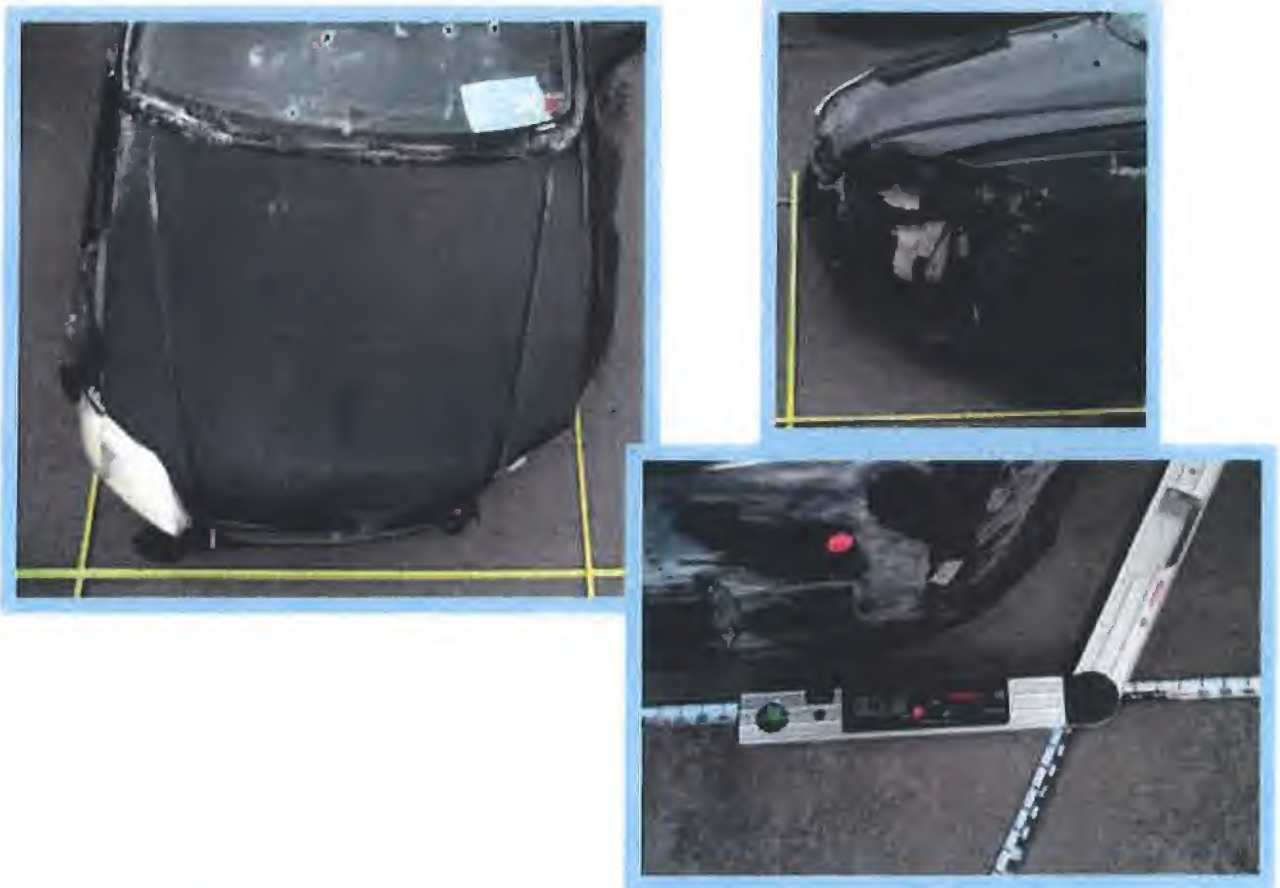
2) Location of Damage: Left Frontal Area.

Description of Damage: Front bumper cover paint scuffing/scratching, front bumper cover detachment; structural damage inclusive of rearward deformation of front subframe assembly; obvious toe out condition of front wheels; left wheelbase reduced approximately 2.09 inches.

Analysis of Damage: Consistent with severity of frontal vehicle impact with concrete barrier of Alternate Route 7 (Collar City Bridge).

Images No. 26a, 26b, & 26c These photographs depict the impact damage of the left front of the 2000 Honda Civic, consistent with the violent concrete barrier impact of April 17, 2016. Utilizing digital measuring equipment, the impact angle was determined to be approximately 11.8 degrees (plus) 7.8 degrees (from).

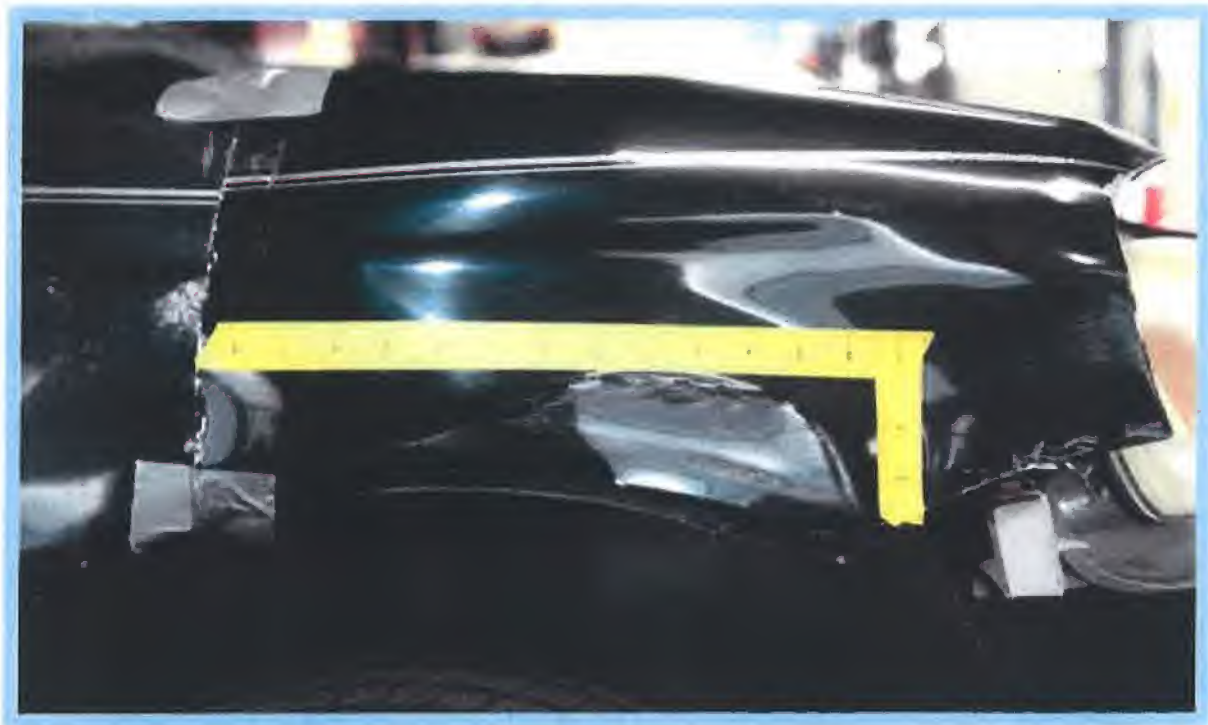
3) Location of Damage: Right Front Fender.

Description of Damage: Paint delamination/striations; paint transfer; inward deformation/stretching of sheet metal.

Image No. 27. This photograph depicts the impact damage sustained by the right front fender of the 2000 Honda Civic, consisting of paint delamination, paint transfer, paint striations, and significant metal deformation/stretching. Digital microscopic analysis revealed that the paint striations were due to left-to-right in the photograph (not in-front-on the vehicle).

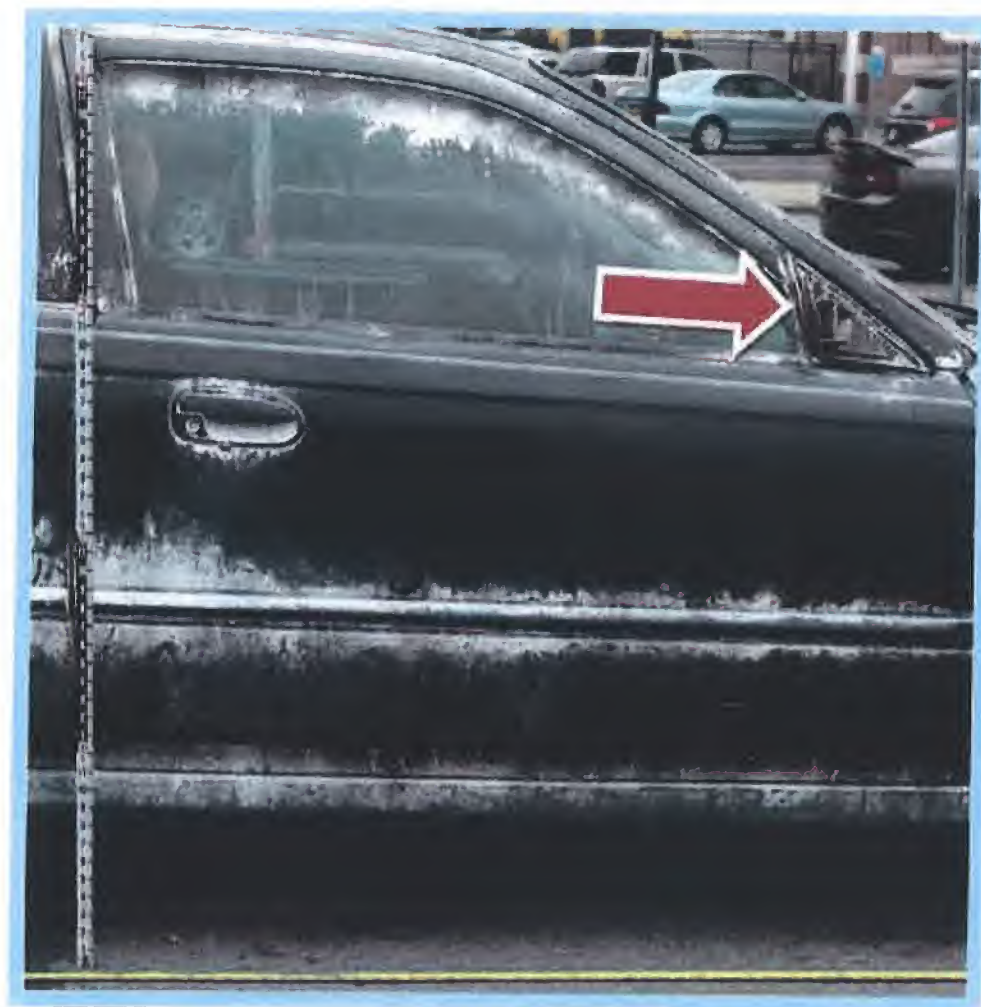
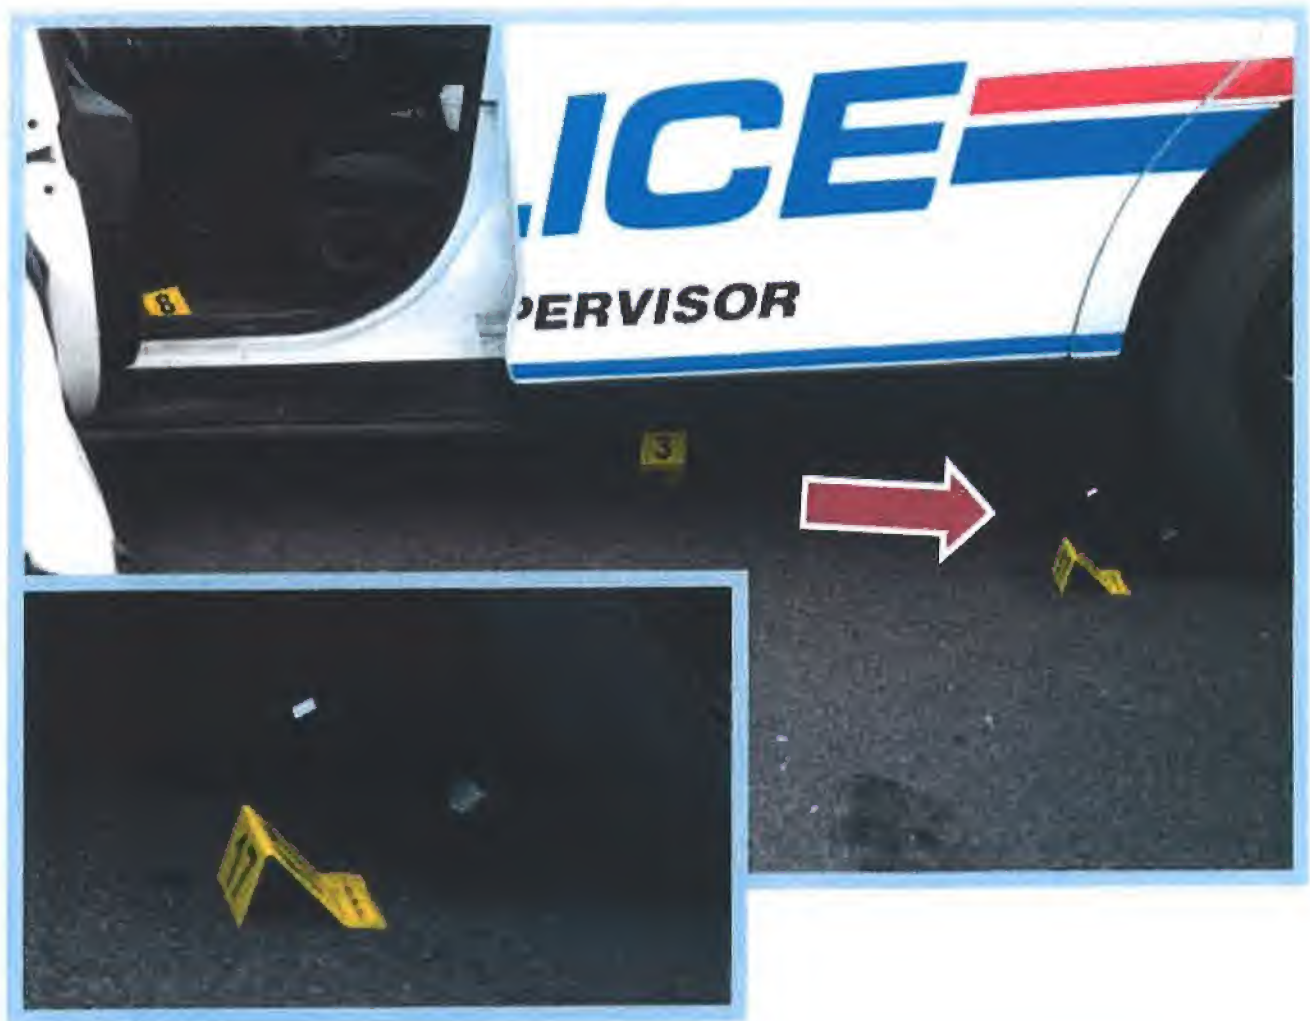
4) Location of Damage: Right Outside Rearview Mirror.

Description of Damage: Forcefully detached in forward trajectory. Paint chipping/striations/scuffing.

Images No. 28a, 28b, & 28c: These photographs depict the right outside rearview mirror location and mirror of the 2000 Honda Civic. The previous page photographs the location of the mirror on the vehicle prior to detachment, while the two photos above denote the temporary final rest location of the mirror in the area of the front of the left rear tire of the 2013 Ford Taurus police cruiser operated by Troy Police Sergeant Randall French at the scene of the April 17, 2016 incident. The mirror exhibited paint striations chipping, with no evidence whatsoever of having been run over by a vehicle tire.

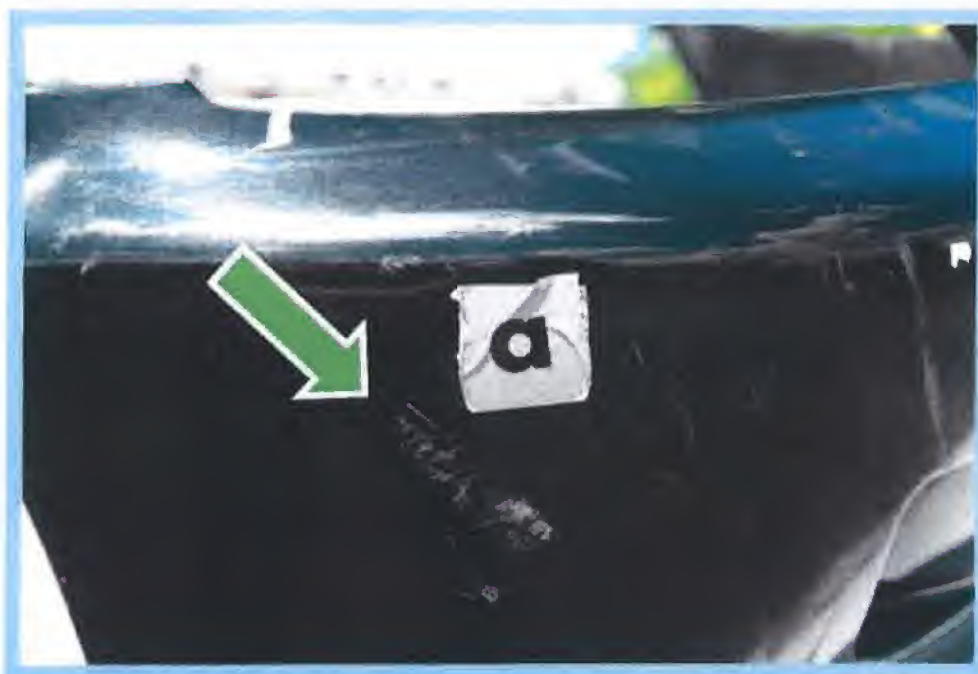
5) Location of Damage: Front Bumper Cover, Right Side (forward of right front tire).

Description of Damage: Paint transfer, striations, scuffing.

Images No. 29 This photograph depicts the right front bumper cover of the 2000 Honda Civic, directly ahead of the right front tire. The Green Arrow denotes paint transfer and scuffing, with striations also present.

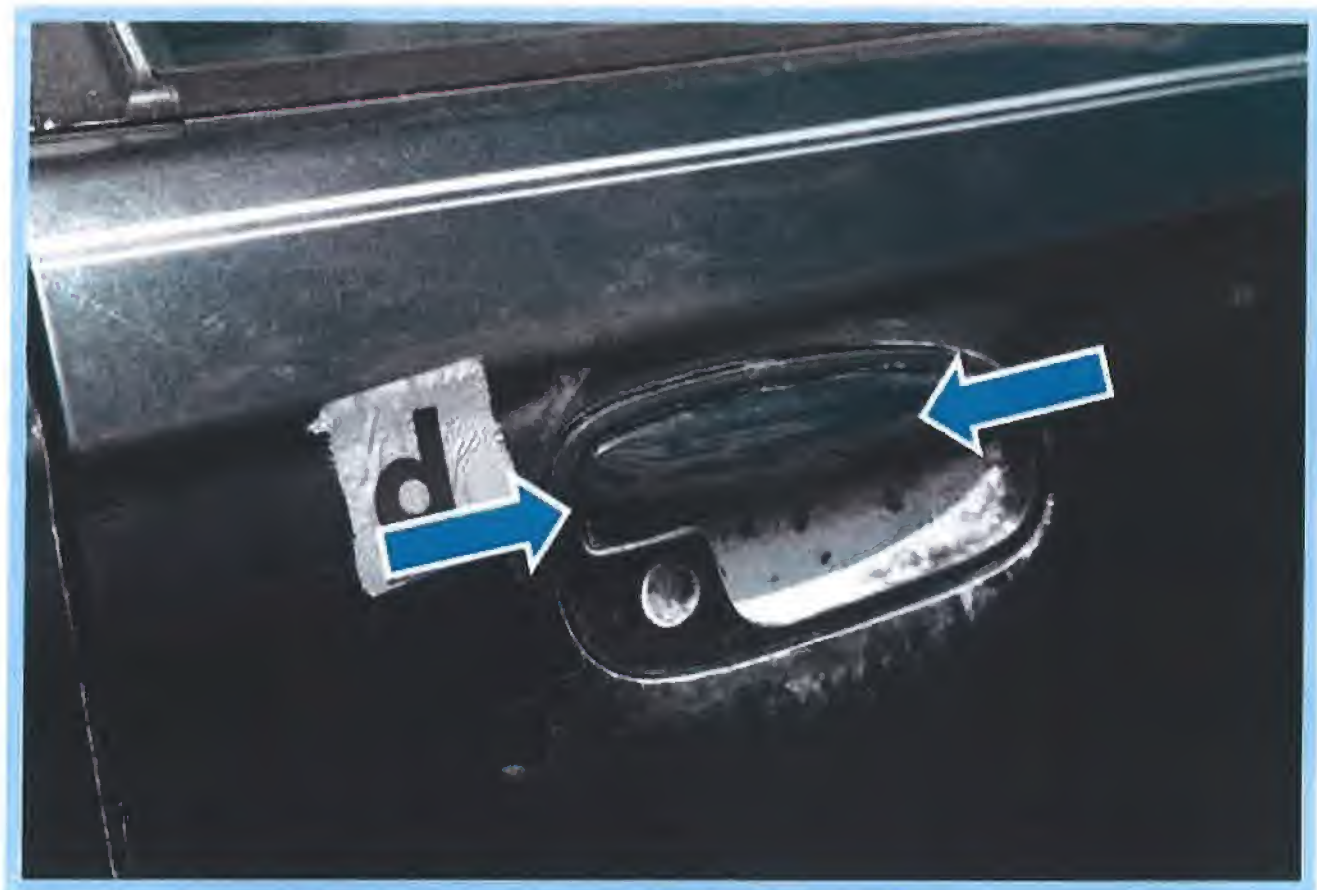
6) Location of Damage: Right Outside Door Handle.

Description of Damage: Paint striations, scuffing.

Images No. 20 This photograph depicts the right outside door handle of the 2000 Honda Civic, directly ahead of the right front tire. Distinctive scuffing was apparent on the pull surface of the door handle forward of the left Blue Arrow, with striations present in the approximate area between the two Blue Arrows. The direction of the damage was left-to-right in the photograph (rear-to-front on the vehicle).

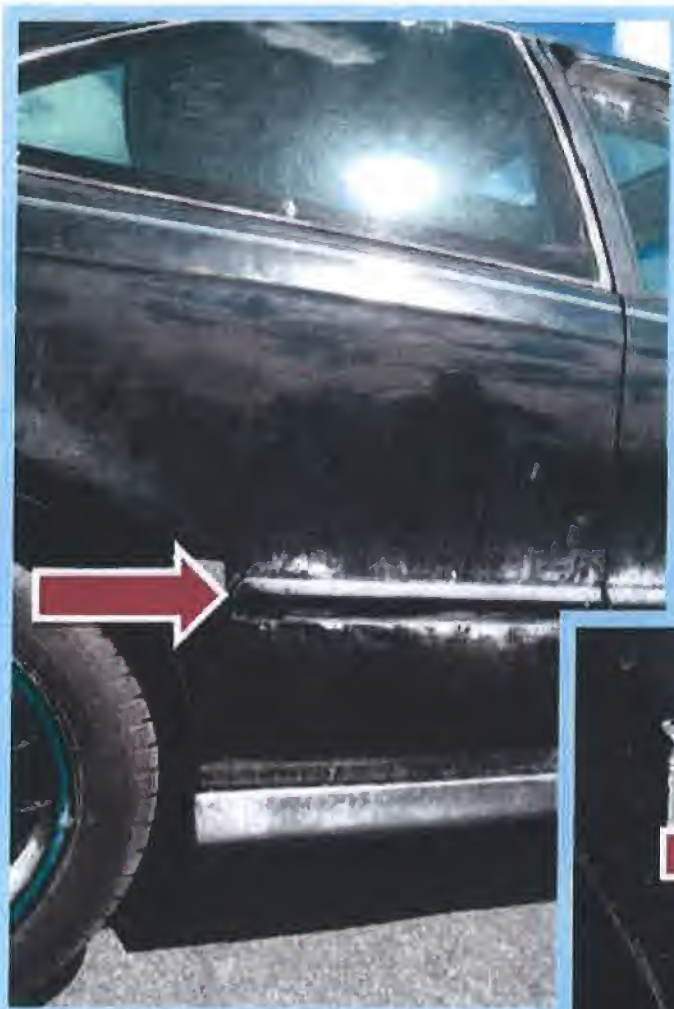
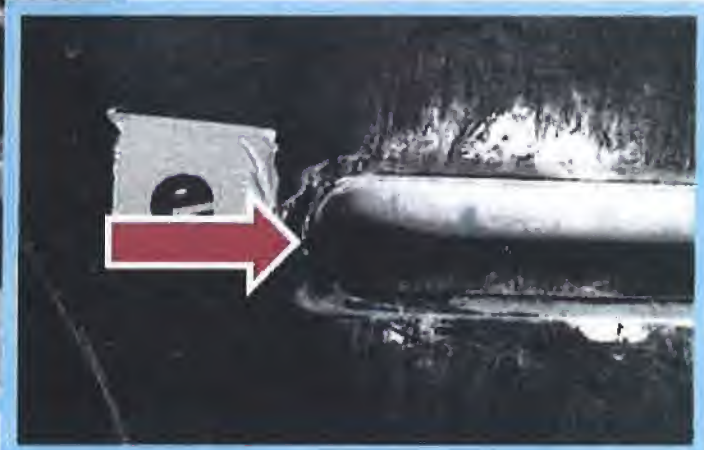
7) Location of Damage: Right Rear Quarter Panel Side Guard Molding.

Description of Damage: Material striations/scuffing; material friction wear.

Images No. 31a & 31b These photographs depict the described damage present at the right side quarter panel side guard molding of the 2000 Honda Civic. Note the obvious friction wear (Red Arrow). The direction of the damage was left-to-right in the photograph (rear-to-front on the vehicle).

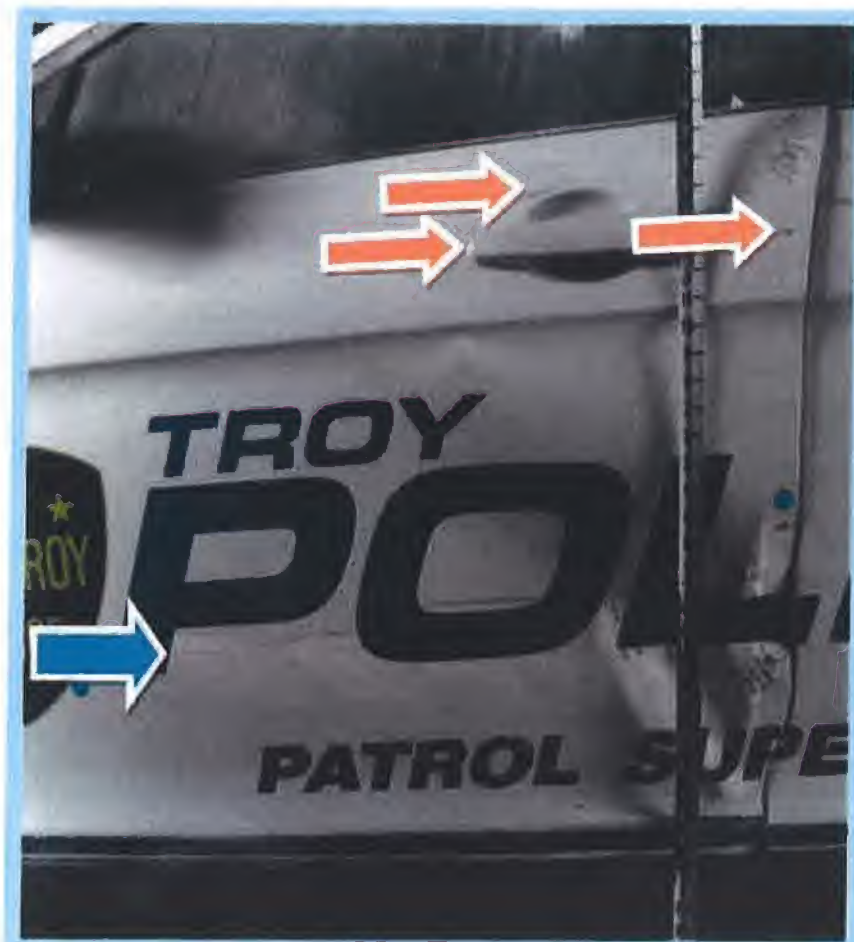
1) **Location of Damage:** Left Front Door, Outer Panel.

Description of Damage: Paint transfer; striations/scuffing; significant outer steel door panel deformation inclusive of creasing, indentation, and buckling; scuffing at outside door handle location.

Image No. 32a This photograph depicts the described minimal contact damage present at the left front steel door panel of the 2013 Ford Taurus. Note the obvious panel deformation in the area of the vertical tape measure. The Orange Arrows denote scuffing transfer at the leading edge, exterior surface, above, and rearward of the outside door handle. The indentation and direction of the damage was that of the Blue Arrow, left-to-right in the photograph (front-to-rear on the vehicle).

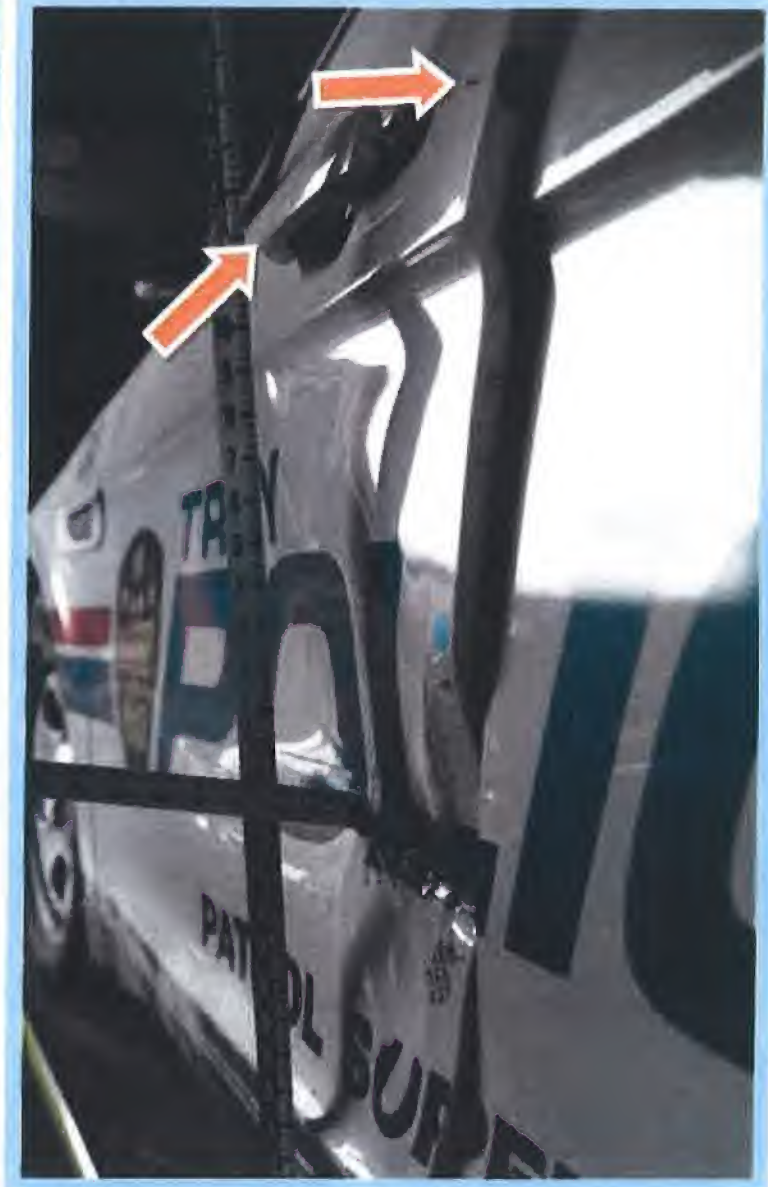
Image No. 32b This photograph depicts the described substantial contact damage present at the left inner steel door panel of the 2013 Ford Focus. Note the significant intrusion and panel buckling due to impact. Also note the scuffing present on, and to the rear of the interior door handle (Orange Arrow). The referenced exterior door handle was displaced slightly rearward from front-to-rear forces.

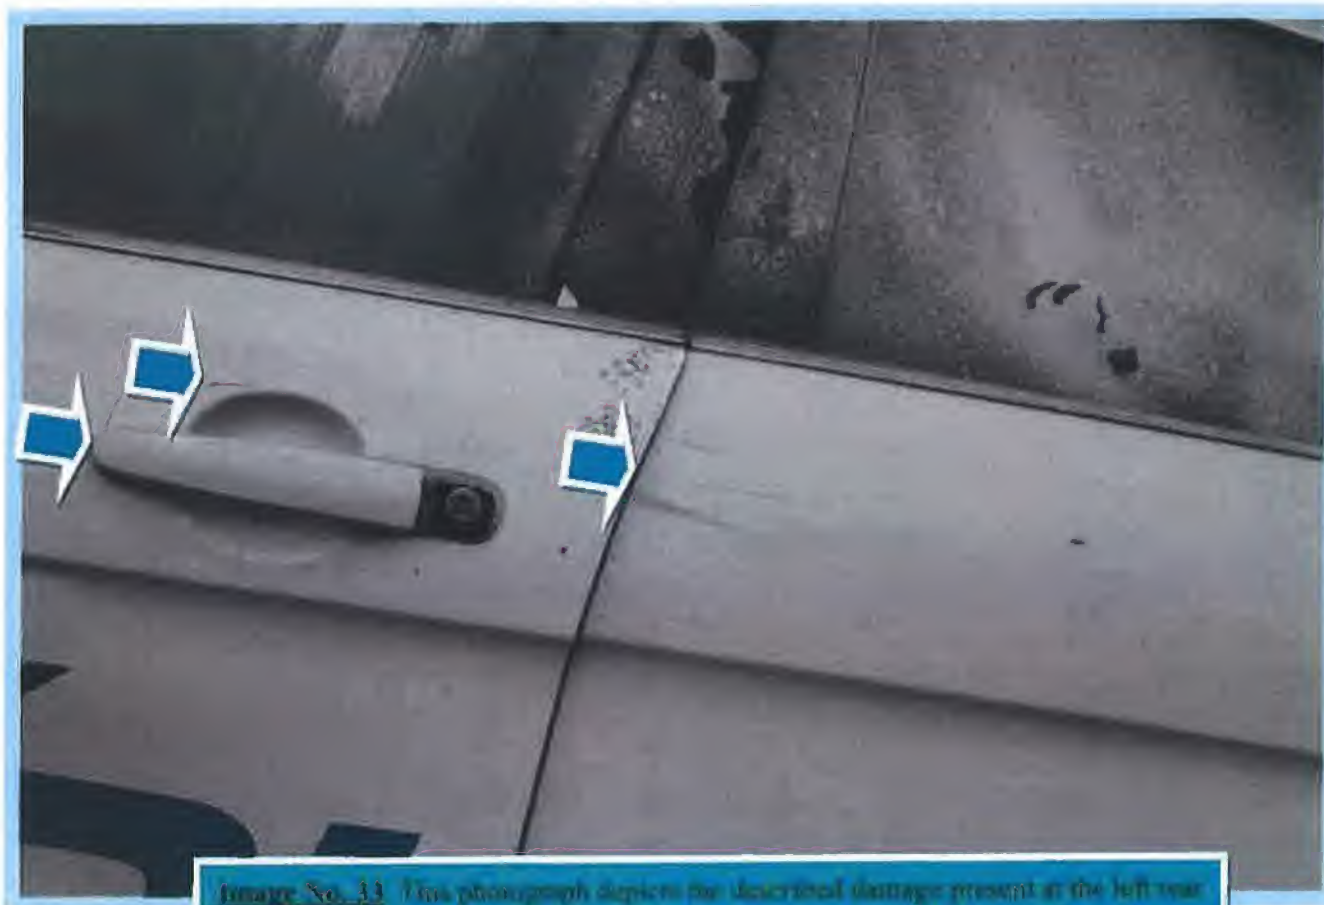
2) Location of Damage: Left Rear Door, Upper Forward Outer Panel.

Description of Damage: Striations/scuffing/transfer -- continuous rearward from left front outer door handle damage.

Image No. 33 This photograph depicts the described damage present at the left rear door upper forward outer panel of the 2013 Ford Taurus. Note the obvious scuffing/transfer (Blue Arrows). The direction of the damage was left-to-right in the photograph (front-to-rear on the vehicle).

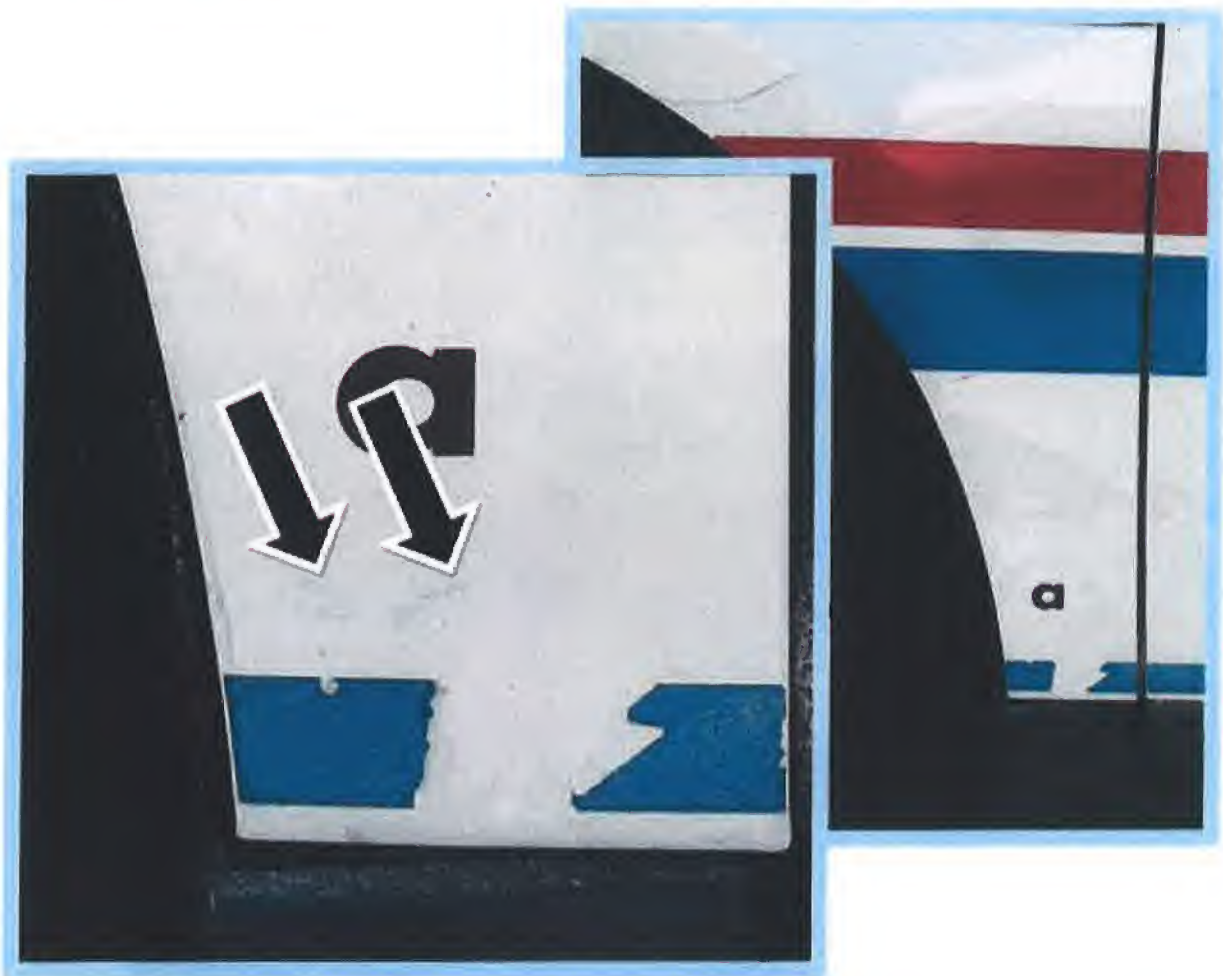
3) **Location of Damage:** Left Front Fender, Lower Rear Section.

Description of Damage: Striations/scuffing/transfer.

Image No. 34 This photograph depicts the described damage present at the left rear lower front fender panel of the 2015 Ford Taurus. Note the obvious scuffing/transfer (Black Arrows).
